***"Il radar olografico come nuovo metodo di  
indagine per la valutazione di elementi  
strutturali e architettonici"***

***Lorenzo Capineri***

***Laboratorio Ultrasuoni e Controlli Non  
Distruttivi, Dip. Elettronica e  
Telecomunicazioni  
Università di Firenze***

Museo Civico di Rovereto , VII Workshop di Geofisica, 10 Dicembre 2010

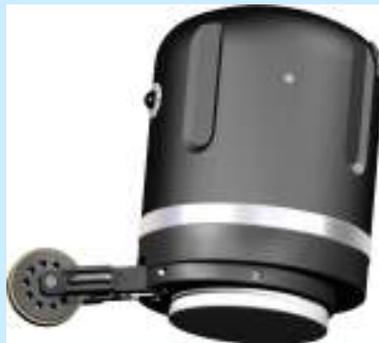
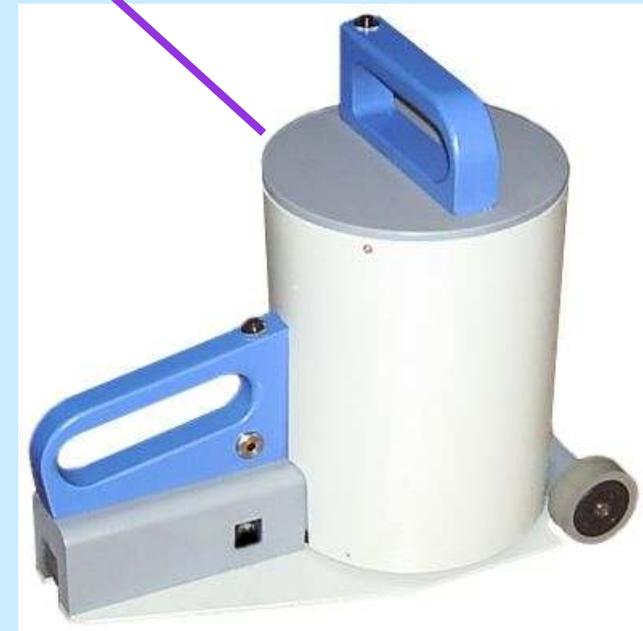
# RASCAN-series radars

RASCAN-4/4000, 4 GHz  
RASCAN-4/7000, 7 GHz

RASCAN-4/2000  
2 GHz

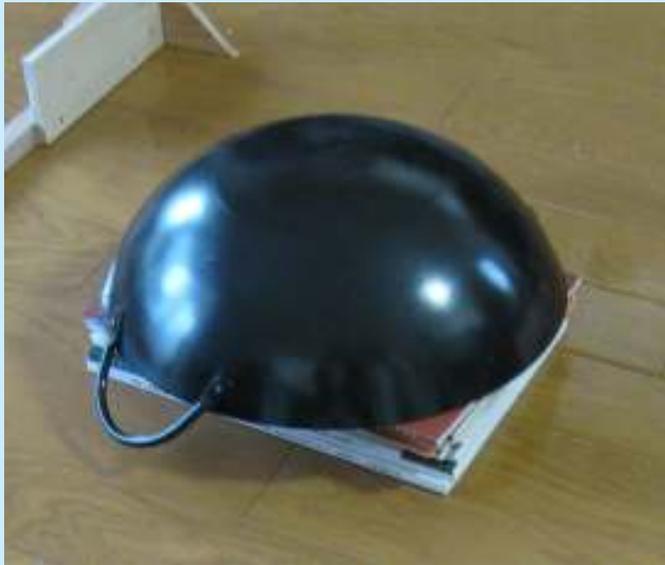
# Interference patterns (Zebra shift)

A scan in air at 5 frequencies close to 4 GHz ( $\lambda = 7.5$  cm) of a metal bowl with concavity up.

As frequency increases  
Shrinks inwards

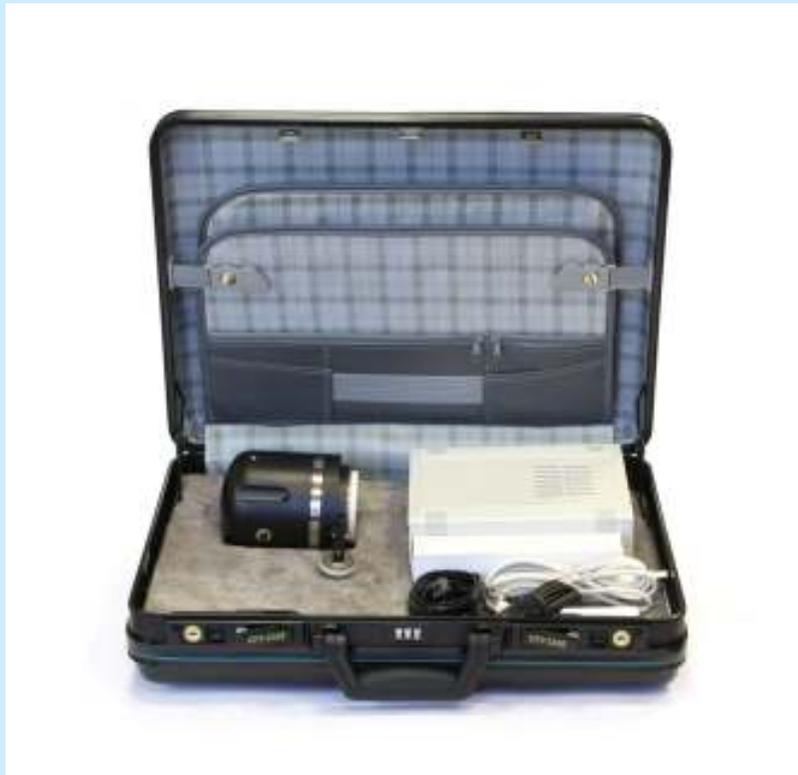
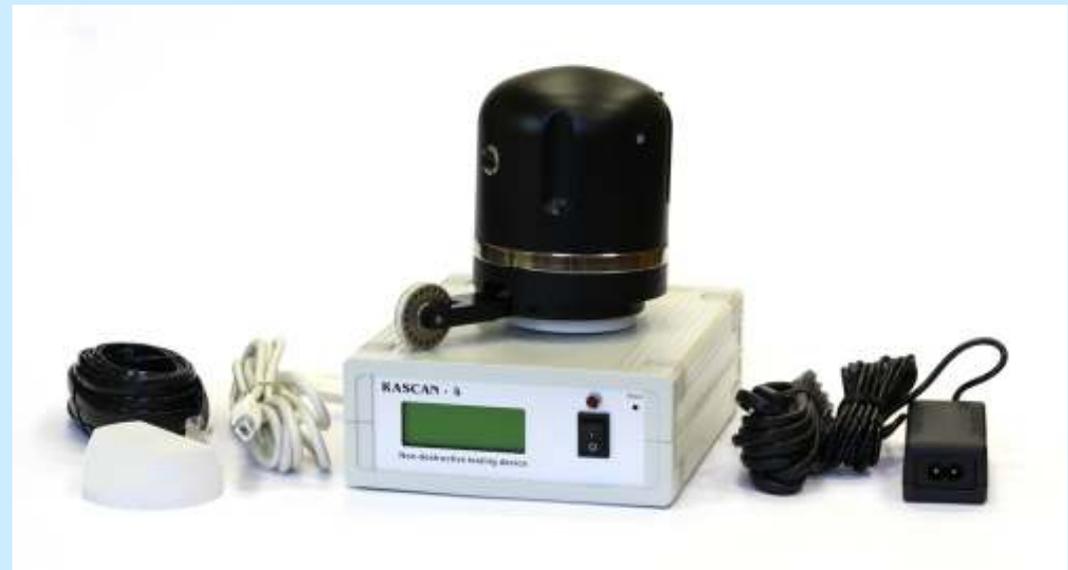
# Holographic RASCAN-4/4000 (4GHz) radar

- RASCAN head 4GHz with control unit
  - Each point is sampled at 5 frequencies, from 3.6GHz to 4GHz
  - Each point is sampled at two polarisation: *cross* and *cocross*
  - A total of 10 images are produced
- Laptop with control software and USB plug
- Small battery

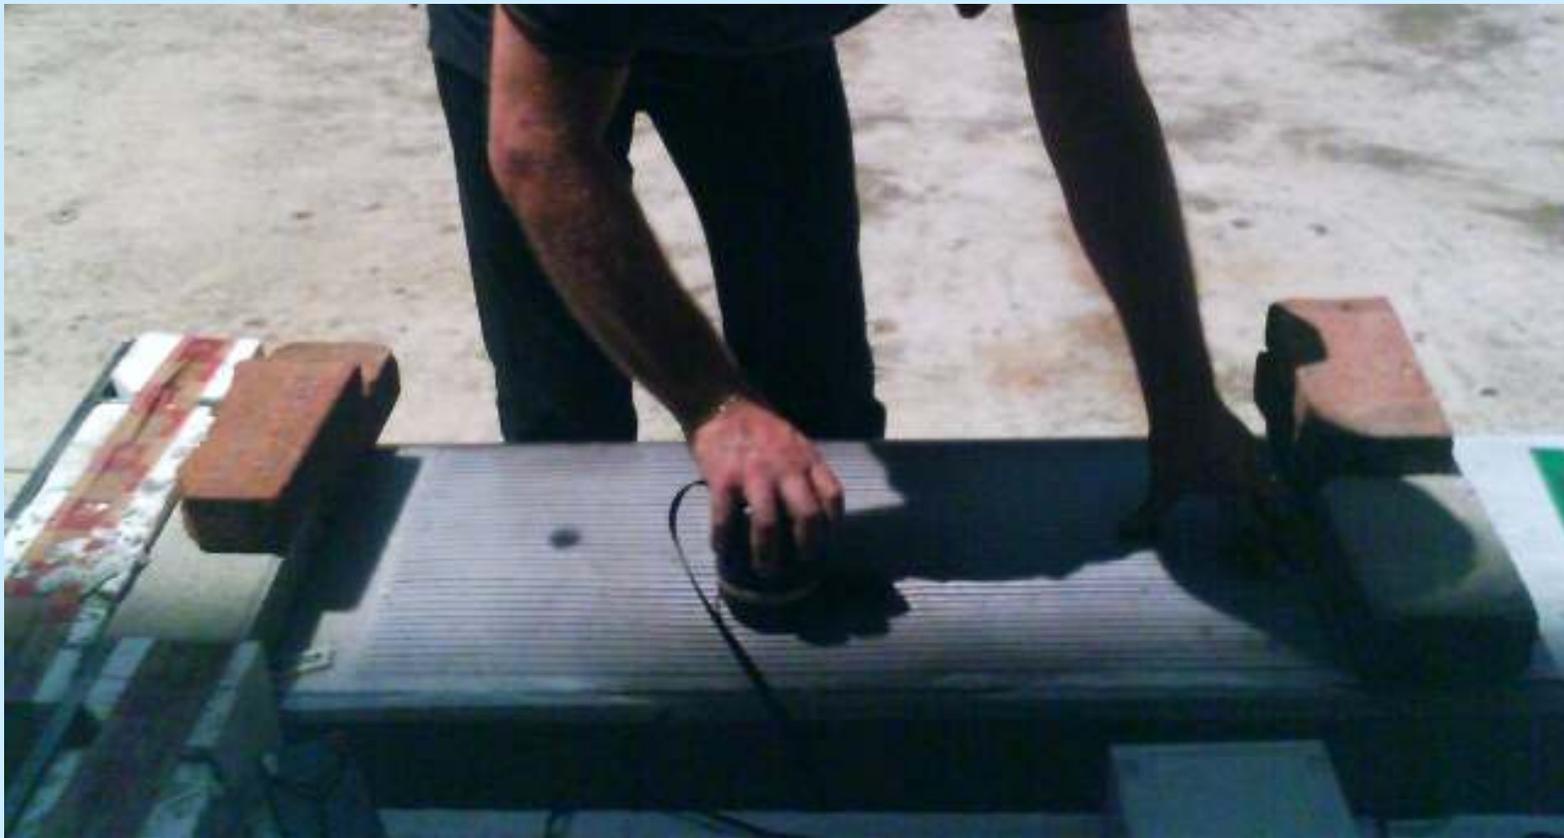
# Column 1 Scan 1

Longitudinal scan, 60x30cm<sup>2</sup>

- An experiment has been conducted on civil engineering structural elements, columns and girders, with the aim of detecting reinforcement bars
- By using RASCAN 4GHz, relative positions and mutual distances can be measured directly from the output of the device
- Image is easy to interpret as it reproduces a plan view of the buried structures

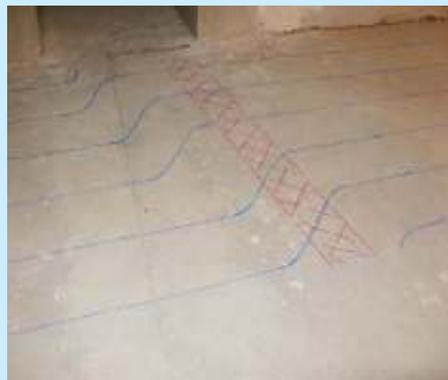
Subsurface features accurately marked on actual the floor

Radar image of unknown pipes in old concrete floor of the Russian Senate Building, Saint Petersburg scan area 1.70m x 8.04m

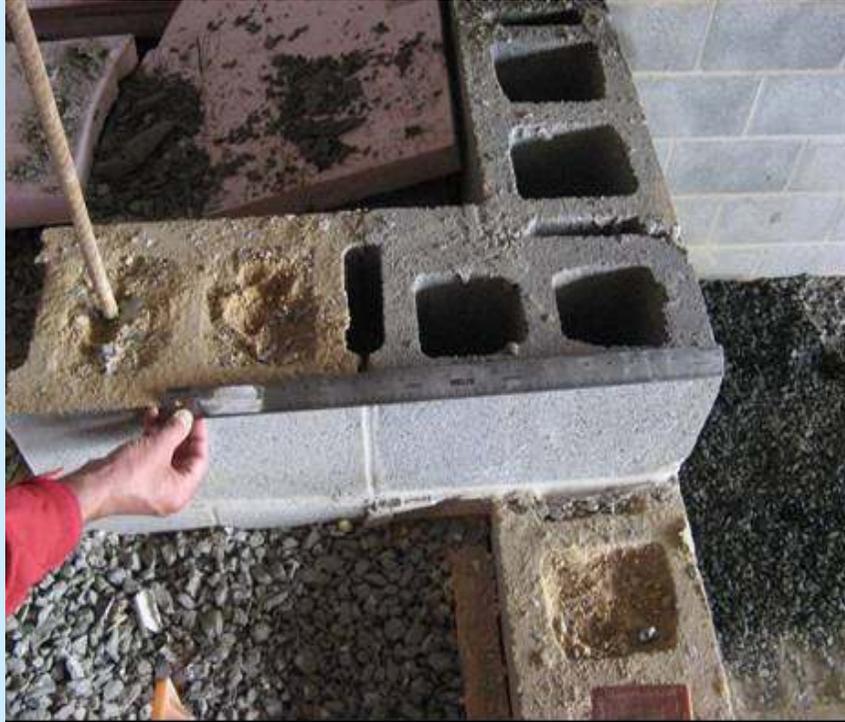
Concrete blocks with dimensions about  $40 \times 24 \times 20 \text{cm}^3$ . The internal part of the blocks has two holes of  $12.5 \times 16 \text{cm}^2$

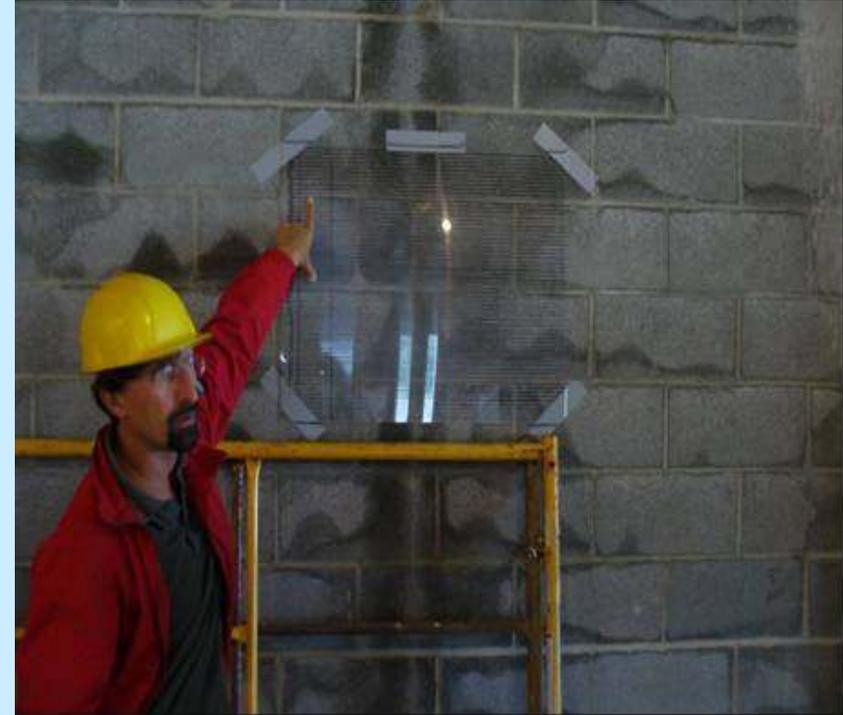
Scanning the wall by using a ruled plastic mat. Wet spots are present

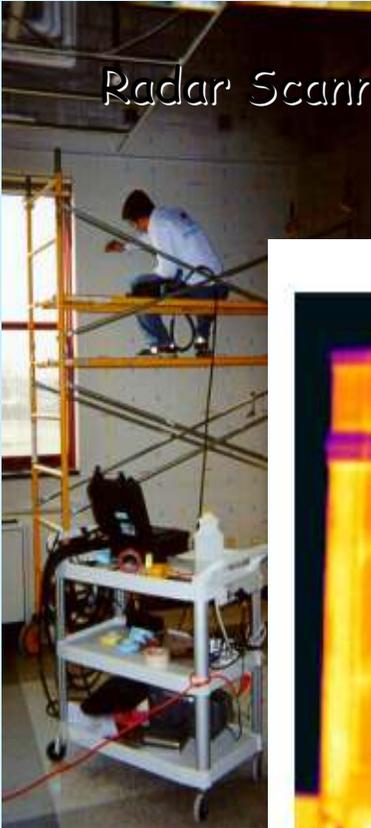
# IR is Faster for large Walls

But, must be supplemented by EMI to locate steel bars

Notes:  
Images recorded xx/xx/xxxx between 4:30 and 6:30 AM (prior to sunrise) using a FLIR i60 ThermoCam.

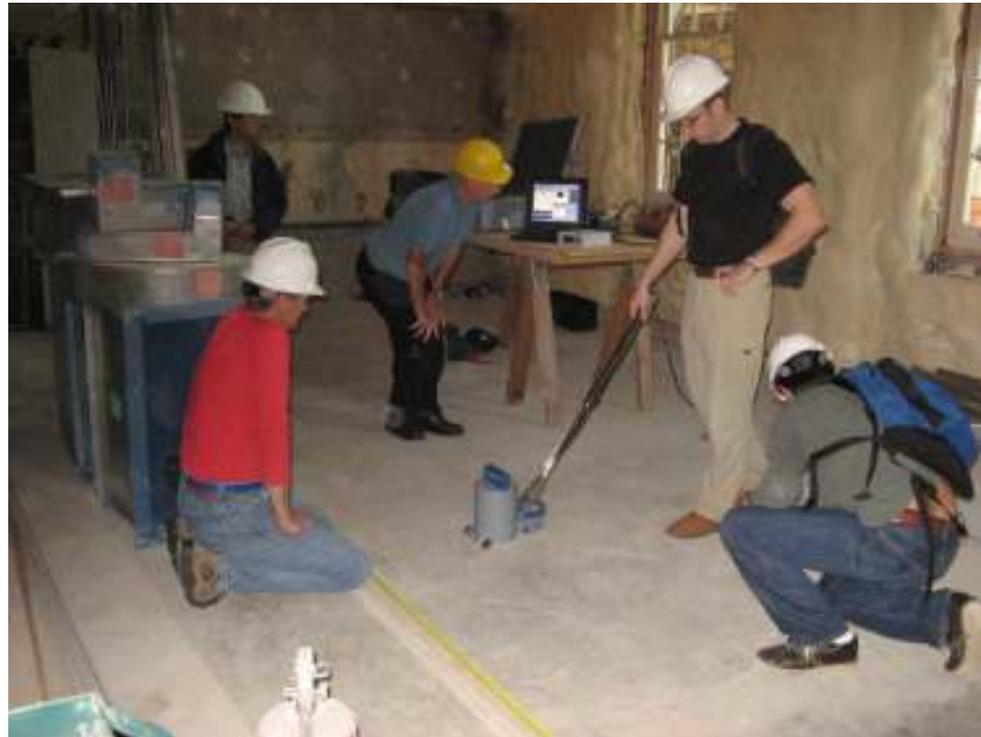
Scan on floor surface with RASCAN 2 GHz

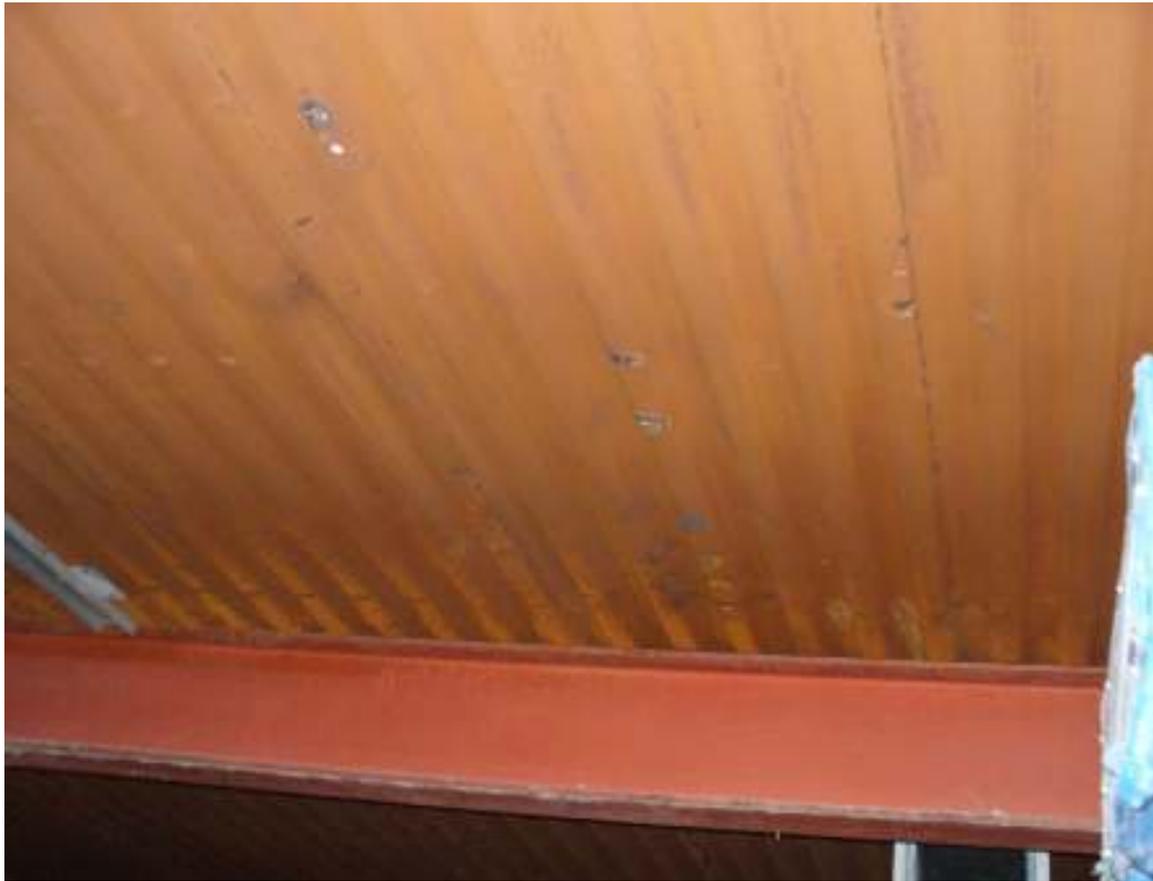
## Description of Floor Bottom

The corrugated metal plate was about 3cm deep and separated by 13cm. The concrete also holds rebars and conduits.

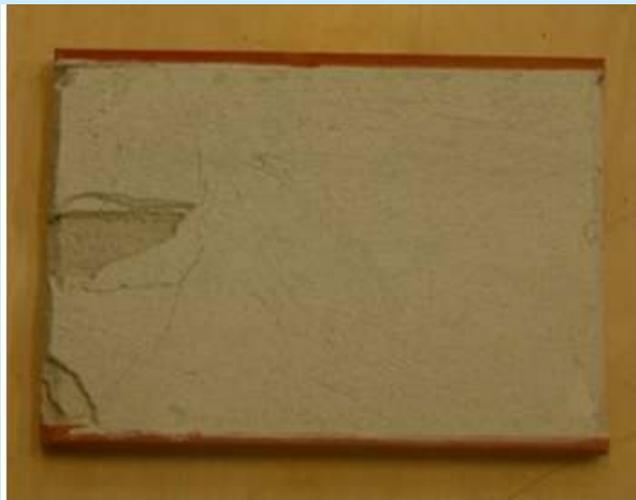
# Holographic radar scans at different frequencies

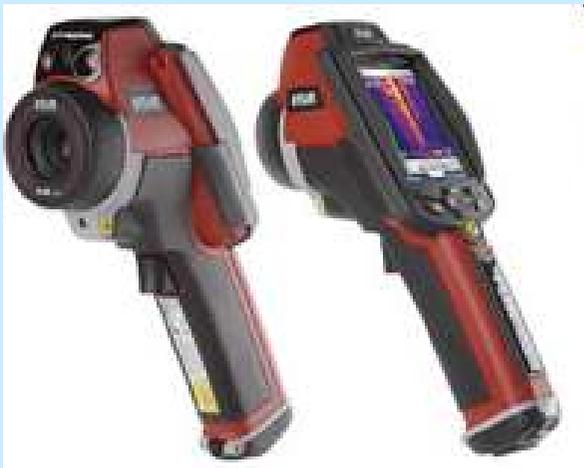
# INFRARED MEASUREMENTS

- The test object heated with two high power (500W) lights for 30 minutes
- The IR camera Mod. B60 (FLIR) with sensitivity better than  $0,07\text{ }^{\circ}\text{C}$  and focal plane array sensors  $180\times 180$  pixels

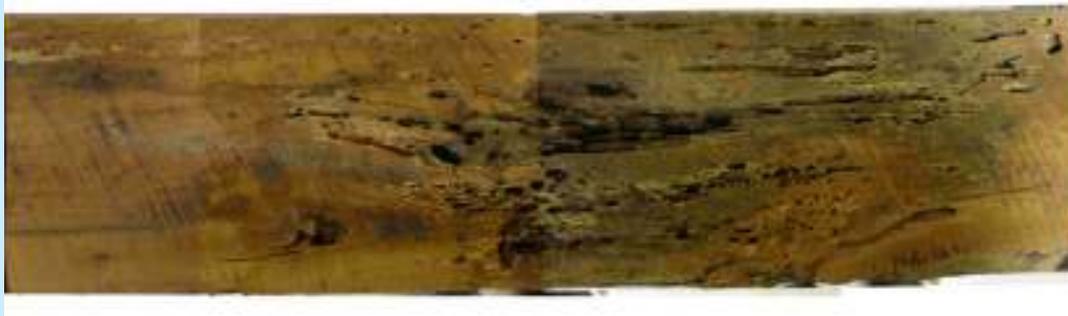
# IRT vs. Radar

90 x 31 cm board exposed

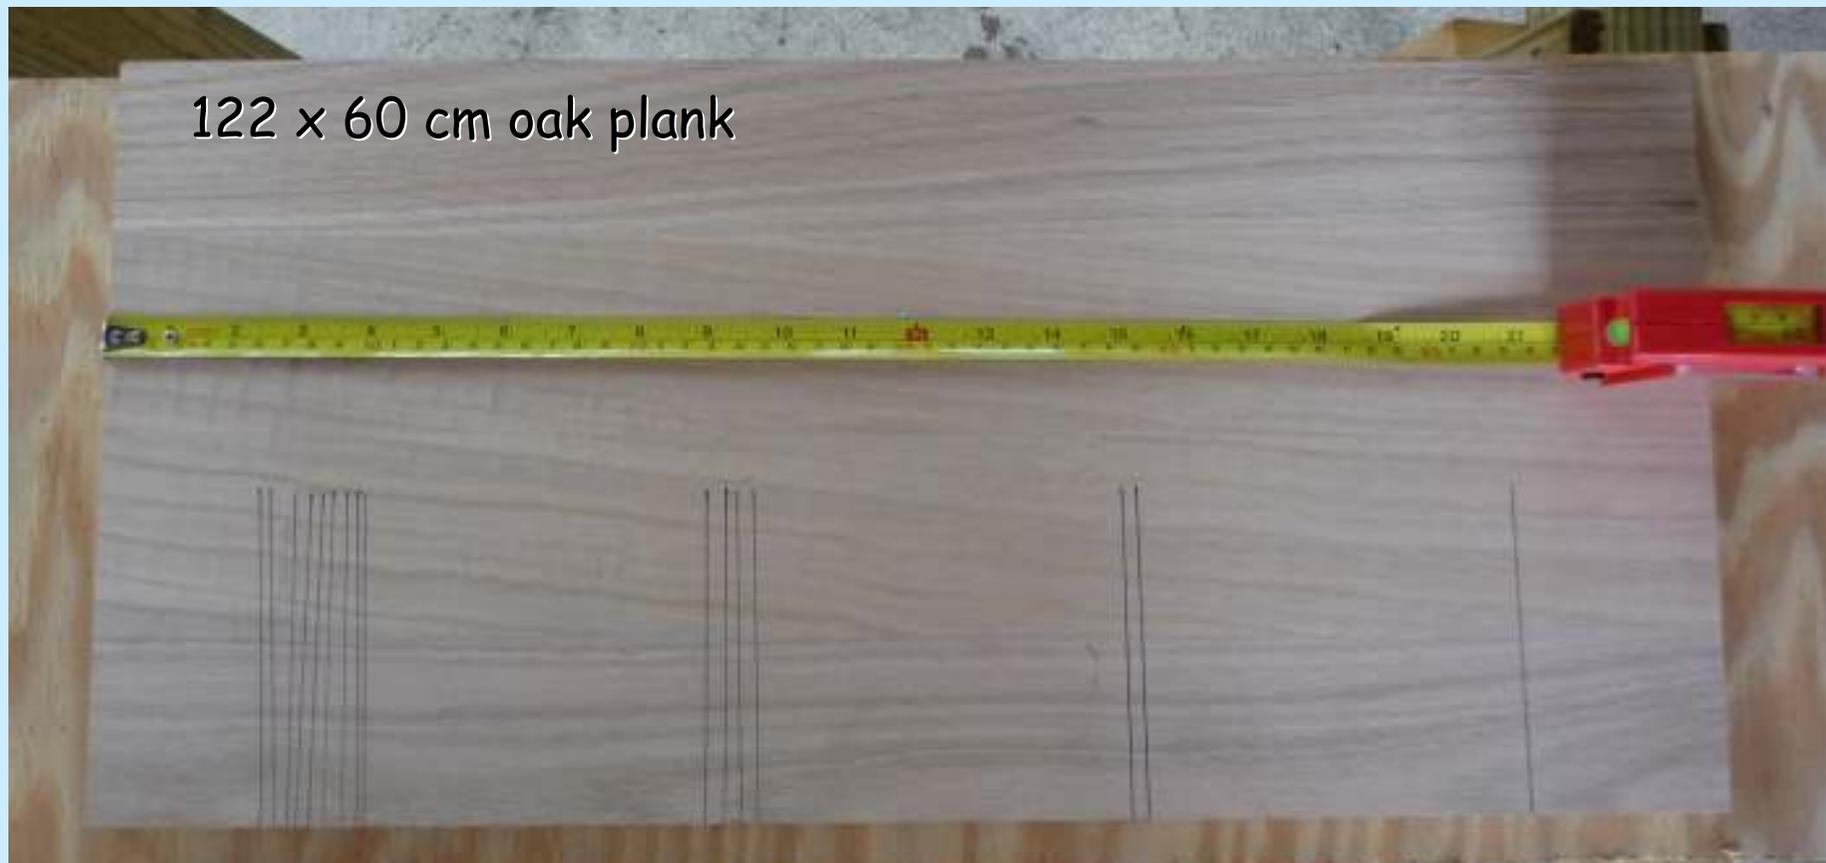
# Radar Test on Board with Mock Damage

Tunnels mimicked by 5 mm diameter horizontal holes, drilled 12 cm length from edge in groupings of 1, 2, 4, and 8.

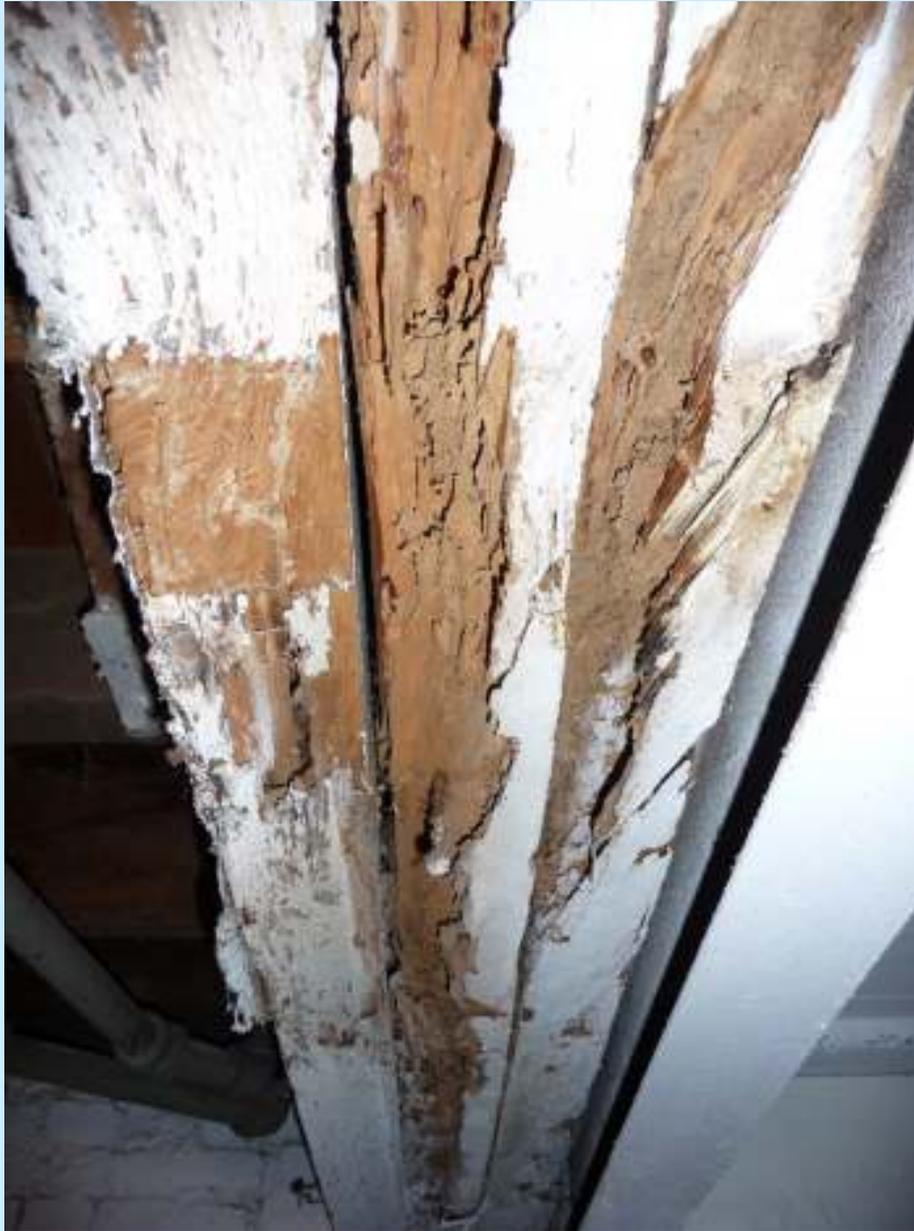
# Blind Test for Actual Damage

Radar was used in a building with heavy termite damage, from an old (>10 years ago) infestation.

Much damage is exposed following destructive testing and repairs.

Is there hidden damage that remains undetected?

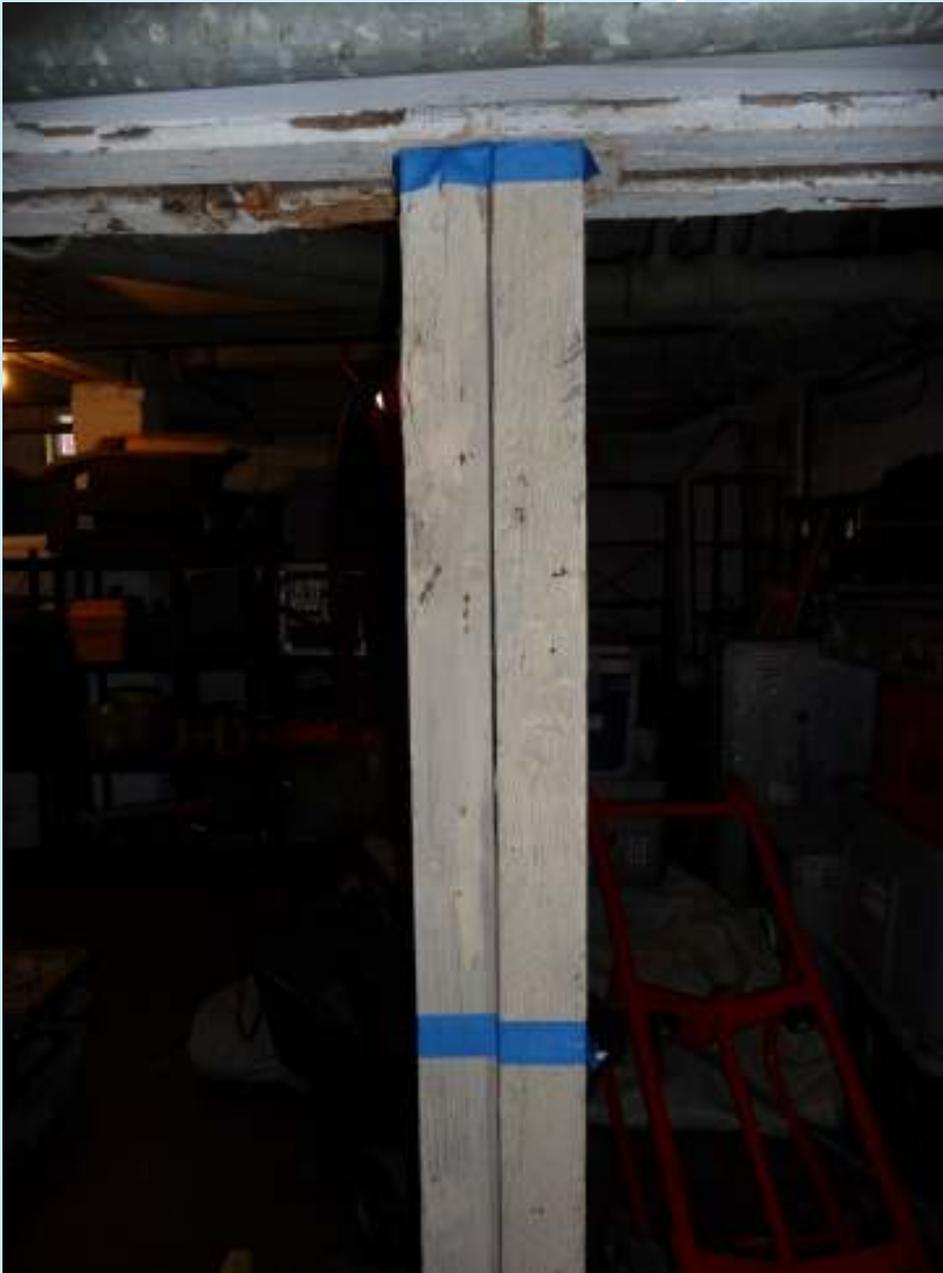
# A Suspicious Location

This double post shows no visible surficial damage, but the beams above do.

Eastern subterranean termites nest in the ground, and rise into structures at night to feed.

Undetected tunnels in the post would provide hidden access from the earth to the damaged beam above.

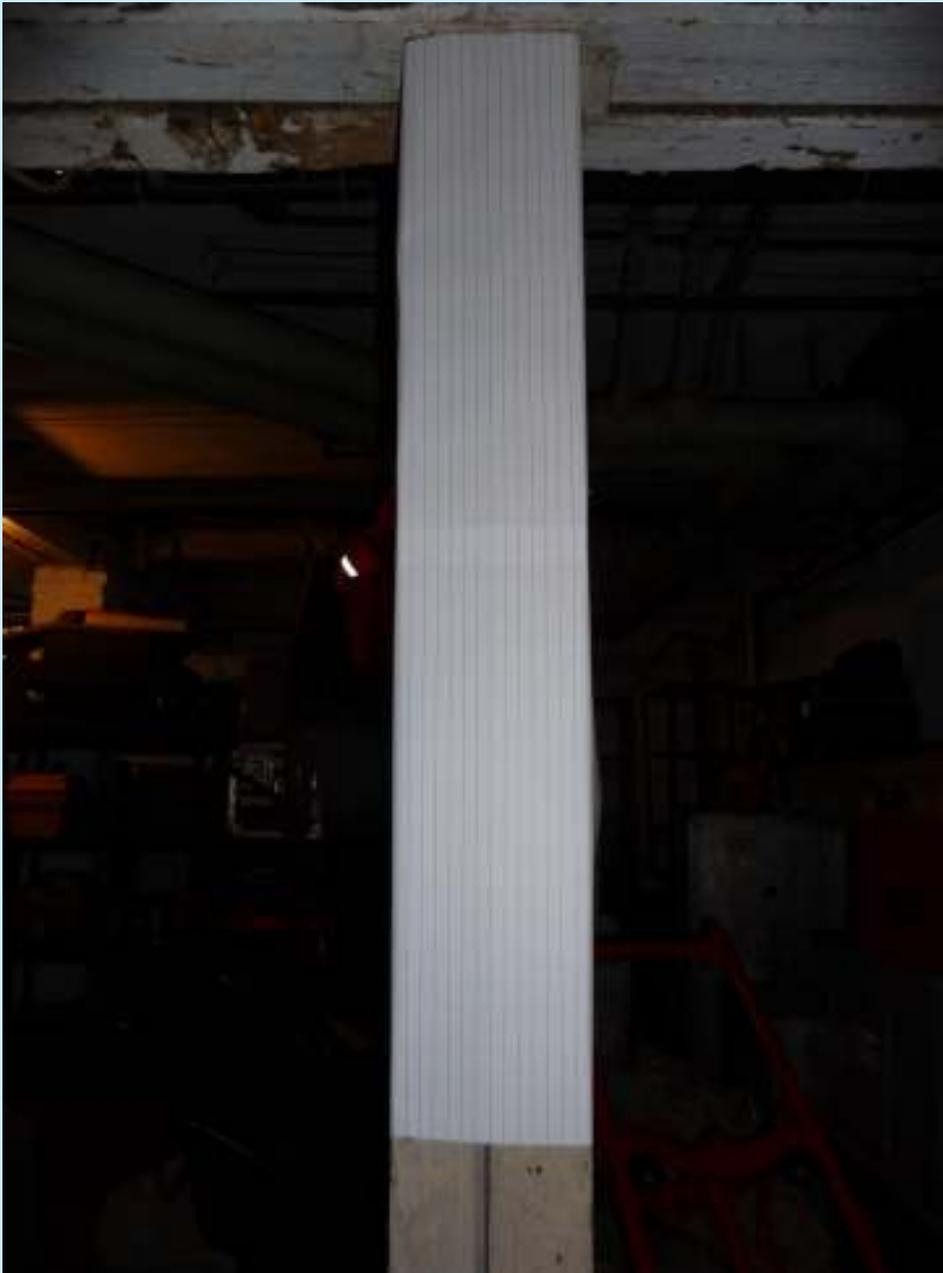
# Radar Testing

The post was scanned with RASCAN-4/4000 along lines spaced at 1 cm.

The scan extended 65 cm down from the damaged beams.

Scanning took less than five minutes.

Results were immediate.

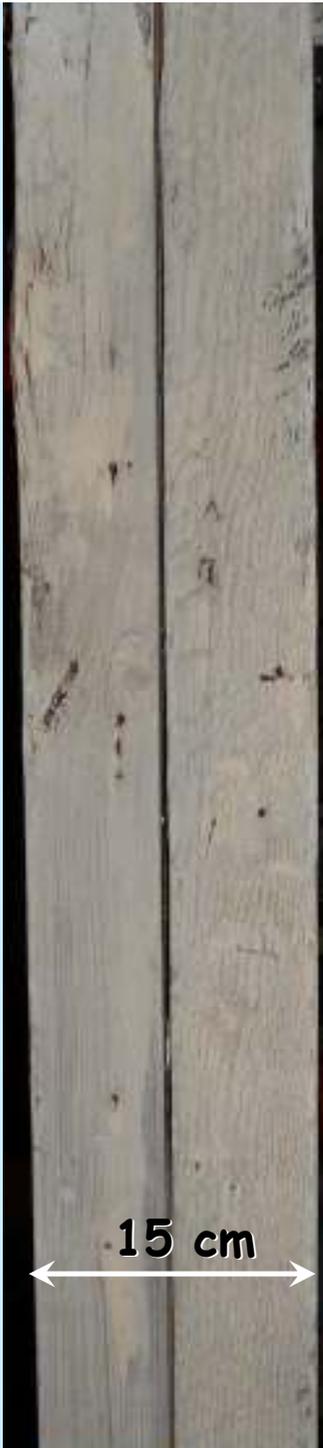
# Interpreting the Radar Image

Possible Damage?

Fasteners?

The seam between planks

15 cm

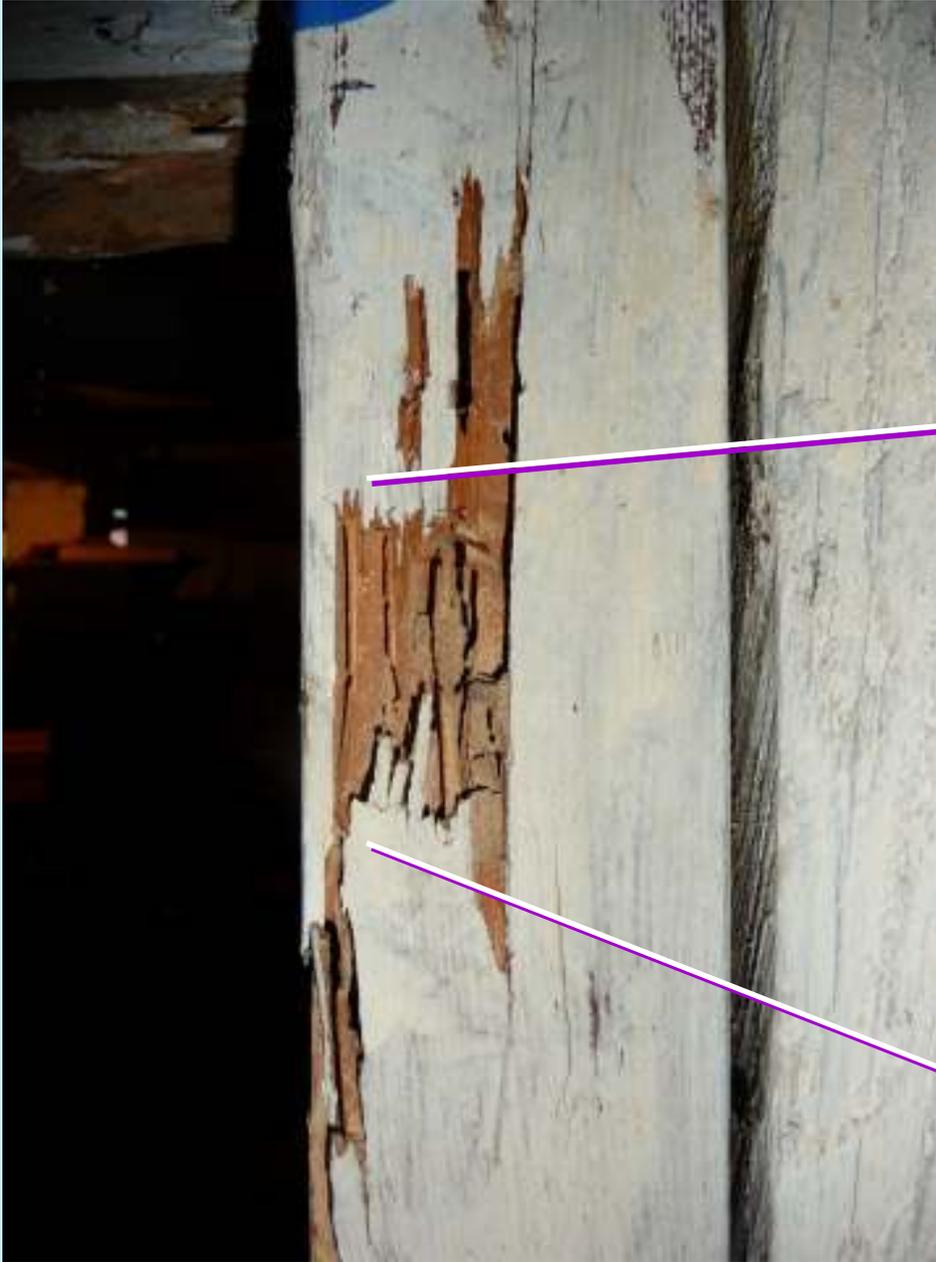
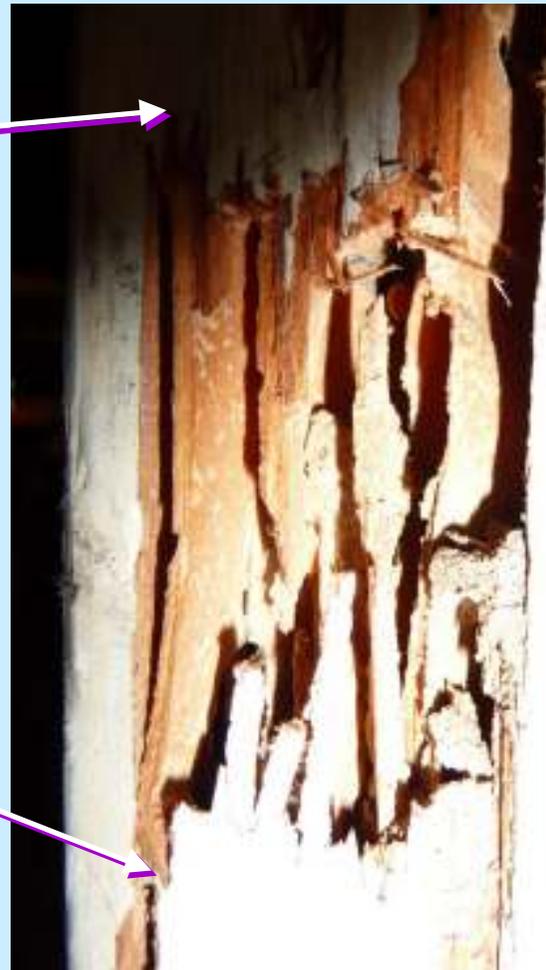
# Damage Revealed

The Radar anomaly was probed with a screwdriver, revealing hidden tunnels.

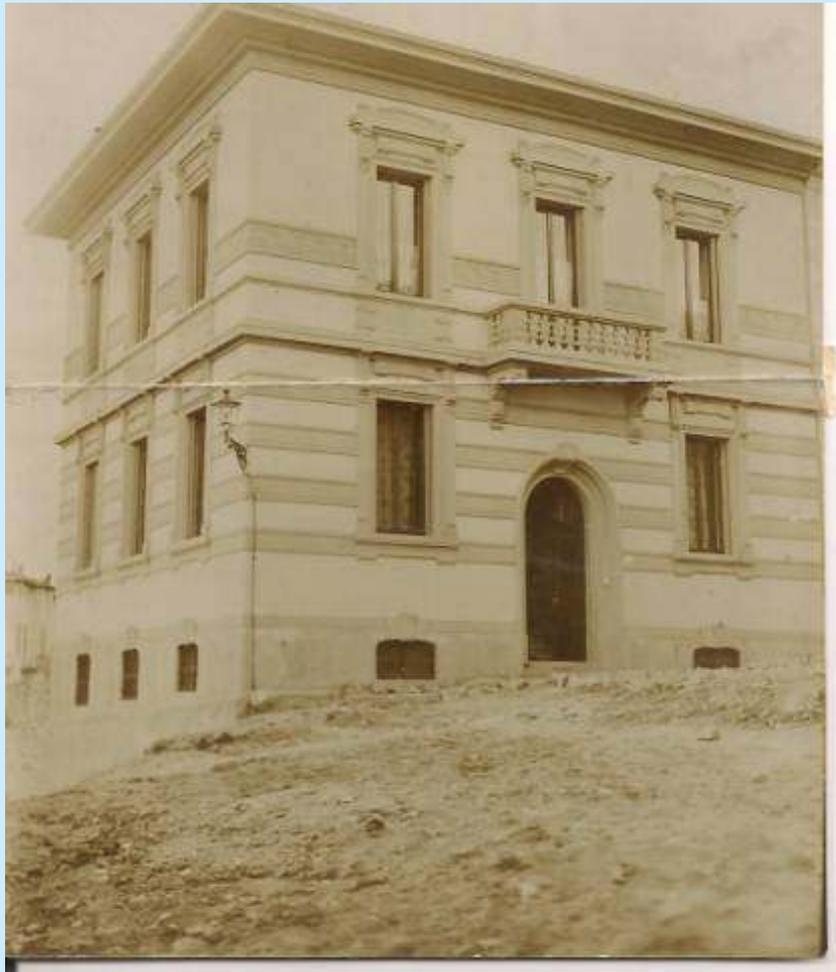
# SITE DESCRIPTION

The measurements have been carried out on an internal wall of a basement floor of a building built on about 1920.

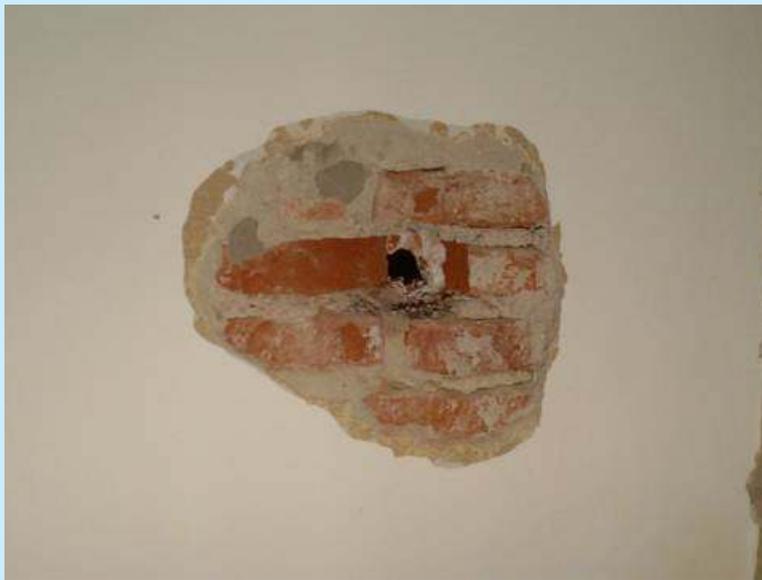
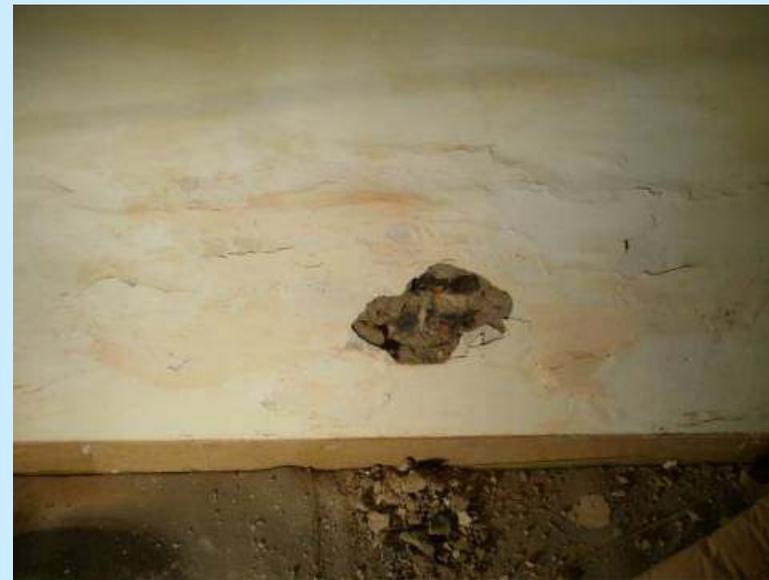
# PICTURES OF THE WALL

Higher area- low moisture

Lower area-high moisture and delaminations

The section of the original bricks (about 100 years old) has dimension 28 cm x 4 cm , separated by mortar with thickness of about 2 cm. The plaster coating has a thickness of 1.5 cm for area #1 and about 3 cm in the lower moisten area

- ❑ The presence of moisture accumulated during at least 50 years in the wall has deteriorated the plaster coating and its thickness increased from 1.5cm in the normal dry area up to 3cm in the moisten area.
